HOLIDAY LAKE DAM

NJ 00061

PHASE 1 INSPECTION REPORT

NATIONAL DAM SAFETY PROGRAM

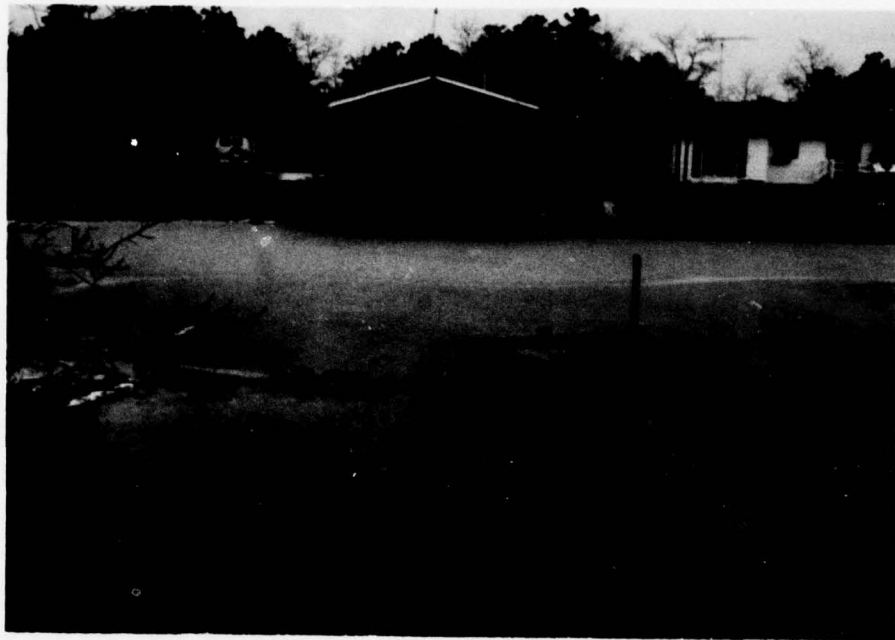
Most of the corrugated metal drop inlet spillway was covered, submerged or buried at the time of inspection and, therefore, could not be observed. The corrugated metal trash rack and anti-vortex cover appeared to be in good condition. However, much of the asphalt coating had peeled off of the surface and the metal had become somewhat rusted. The flared end section at the spillway discharge culvert outlet contains some rust but otherwise is in good condition.

PHOTO 1
SPILLWAY STRUCTURE

2. The asphalt coating on the anti-vortex assembly should be renewed after rust is removed.
3. Erosion on the downstream embankment slope should be filled, compacted and sodded.
4. A suitable stand of grass should be established on the bare sections of the embankment.
5. Access to the dam by motor vehicles should be prevented by constructing barriers at each end of the embankment.
6. Riprap on the upstream face of the embankment should be renovated by the placement of additional stones.

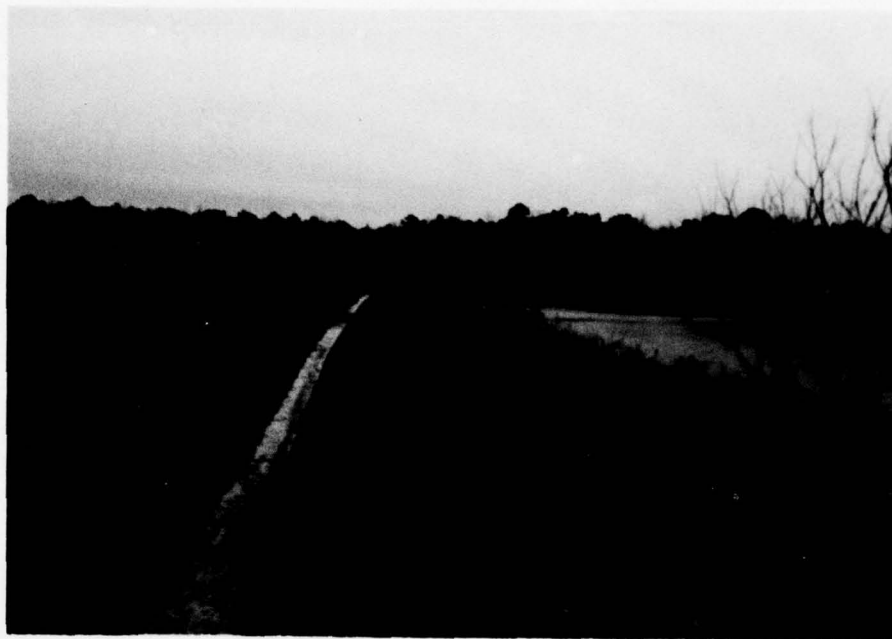
The dam embankment appeared to be uniformly aligned both vertically and horizontally with a good stand of grass covering most surfaces. A path located along the dam crest as well as some sections of the downstream slope lack grass cover. A few small trees were observed on the embankment. No evidence of cracking or settling was noted nor were any animal holes observed.

PHOTO 3
CREST OF DAM.

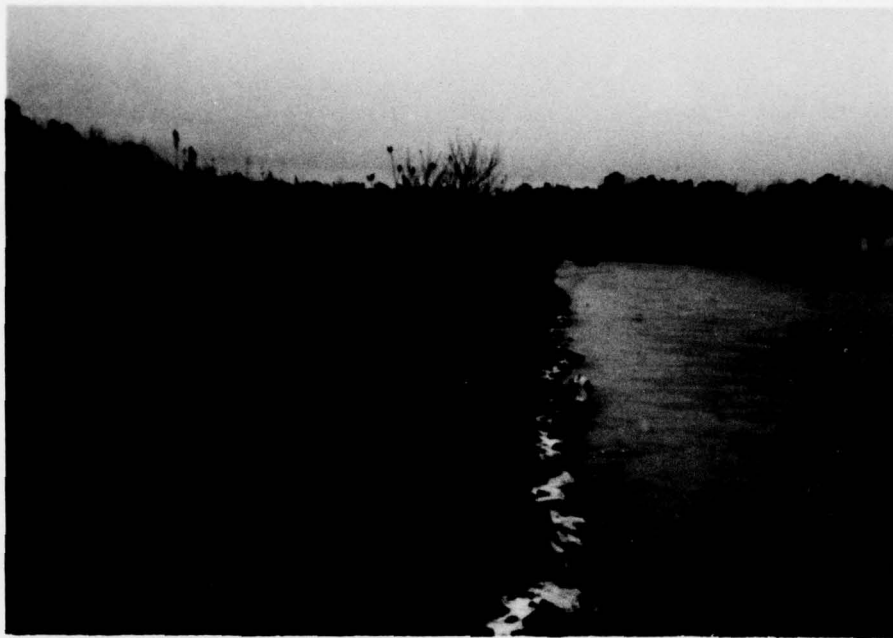
PHOTO 5

Riprap was noted along the entire length of the upstream face of embankment and around the concrete slab used as crest for the emergency spillway. The riprap appeared to be insufficient in quantity to provide adequate slope protection.

UPSTREAM FACE OF EMBANKMENT
